## Investigation of Fretting Fatigue Failure of Stud Bolt

Ing. Radek Tomášek; Ing. Adéla Podepřelová; Lukáš Horskák

VŠB – Technical University of Ostrava, Faculty of Materials Science and Technology, Regional Materials Science and Technology Centre, 17. listopadu 2172/15, 708 00 Ostrava-Poruba, Czech Republic

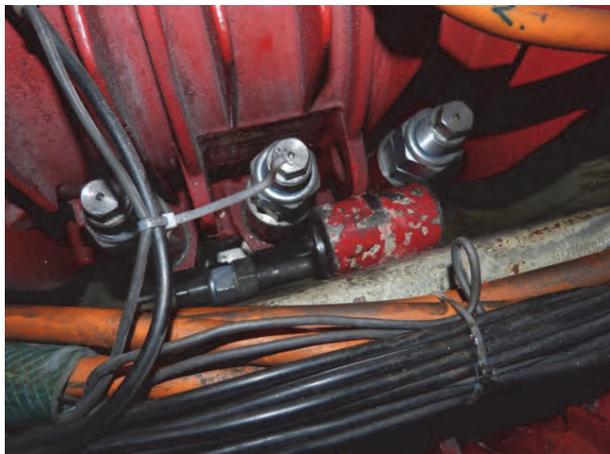
Fig. 1 Image of vibrating engine and stud bolts  
Obr. 1 Obrázek vibromotoru a svorníků

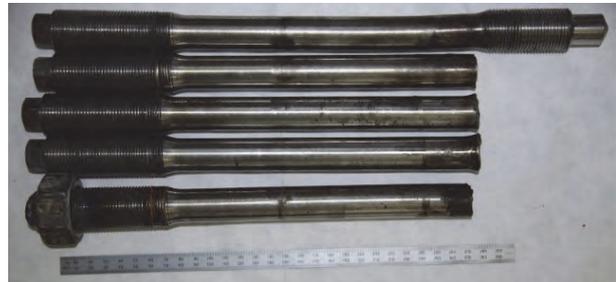
Six stud bolts in total were used to fix vibrating motor, and most of them have failed. Fig. 1 shows one side of the motor with fastened stud bolts and Fig. 2 is an assembly diagram. All of the six stud bolts were provided for investigation. Five of these have already failed, and last unbroken one was significantly damaged by plastic deformation as it can be seen in Fig. 3.

Significant surface damage of reddish deposits and spalling was concentrated around the fracture surface. Most of the provided stud bolts contained markedly damaged fracture surfaces, a clear sign of rubbing against the other half of broken bolt. There was no point in performing fractographic analysis on these bolts.

Fig. 3 Fractured and bent stud bolts  
Obr. 3 Zlomené a deformované svorníky

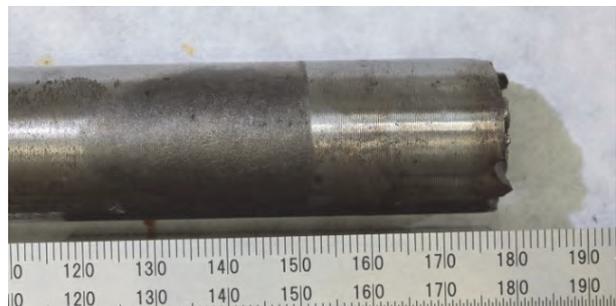
Visual inspection was carried out in the first place by macro photos. The primary finding was that all failed stud bolts have fractured on the side recessed into slab foundation, the upper side was provided with hexagon screw head to fasten bolt in its respective hole. Observation of the surfaces indicated wear marks on bolts reduced section, suggesting that wear occurred between the bolt and its clearance hole.

Fig. 4 Investigated stud bolts - an area of the fracture  
Obr. 4 Analyzovaný svorník – oblast lomu

For this reason, the subsequent material analysis was performed on the stud bolt with most preserved fracture (Fig. 4), which also showed its surface wear marks.

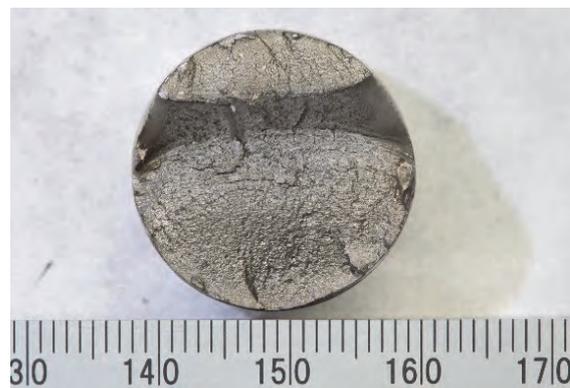
Observation in the scanning electron microscope (SEM) was carried out on the most preserved fracture surface. Separated part of the bolt was ultrasonically cleaned in acetone. Based on the visual investigation, the cause of failure was recognized as fatigue due to the presence of characteristic beach marks as it can be seen in Fig. 5. Two areas with fatigue crack propagation, separated by an area of the final fracture, were present on opposing sides of the cross-section.

Fig. 5 Investigated fracture surface  
Obr. 5 Analyzovaná lomová plocha

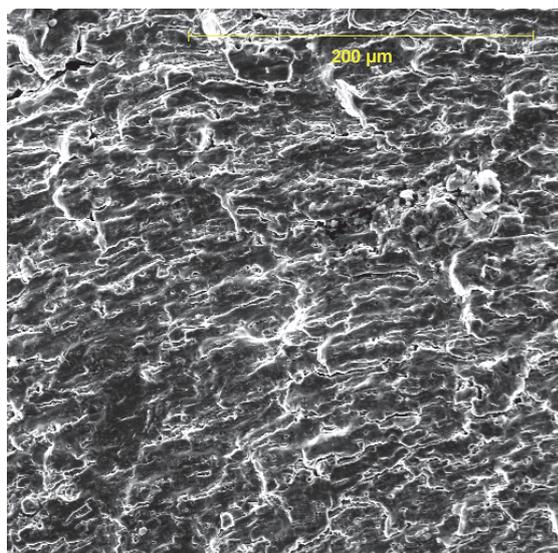
Fatigue striations were observed on the fracture surface (Fig. 6). Precise initiation point was found only on one side where the surface of the stud bolt was largely influenced by fretting as shown in Fig. 7 due to contact with the surrounding environment. On the other side, it was possible to pinpoint the area of origin with no precise spot. These findings along with wear marks and presence of black spots and corrosion damage on the surface indicated that fatigue cracks were initiated by the fretting mechanism.

Fig. 6 Fatigue striations on the fracture surface  
Obr. 6 Únavové striace na lomové ploše

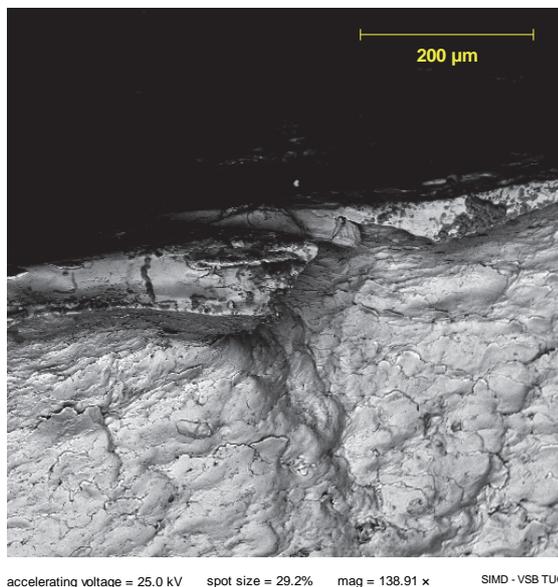
Fig. 7 Initiation area of fretting  
Obr. 7 Místo iniciace a otěru

According to the results of mechanical properties and metallurgical structure, the material of stud bolts was not found defective and should be considered suitable for its application containing both tempered martensite and moderately high yield strength. Presence of two fatigue propagation areas indicated that the surface of the stud bolt was subjected to fretting on opposing sides. After the initial spread of the short cracks, their propagation was further enhanced by alternate bending motion induced by vibrating oscillations of the engine. This process was more severe when more stud bolts failed, causing a cascade effect, because the amplitude of free motion was larger. As it was observed on the last unbroken stud bolt, it has experienced even minor plastic deformation due to excessive loads and large amplitude of oscillations. Severely worn areas were observed on the surface of stud bolts along with already developed cracks. According to general assembly schematics in Fig. 1b, the main cause of failure is due to improper design of the mounting assembly. The surface of stud bolt comes in contact with a base plate underneath the vibrating engine. An actual clearance hole is too large and reduced section of the bolt should be enclosed in the housing ideally. In this case, the amplitude of oscillatory motion caused fretting damage on the lower side of stud bolt.

In this paper, the failure of undercut double end stud bolt was analyzed to determine the failure mechanism with the use of fractography analysis and examination of its microstructure and mechanical properties. Fretting fatigue was identified as the cause of failure because of relative motion between stud bolt and the base plate of vibrating motor. Cracks initiated by fretting were then propagated as fatigue cracks due to alternate bending loading leading to a series of subsequent fractures. Reduction of oscillatory motion or clearance hole redesign is necessary to prevent such failures in the future.

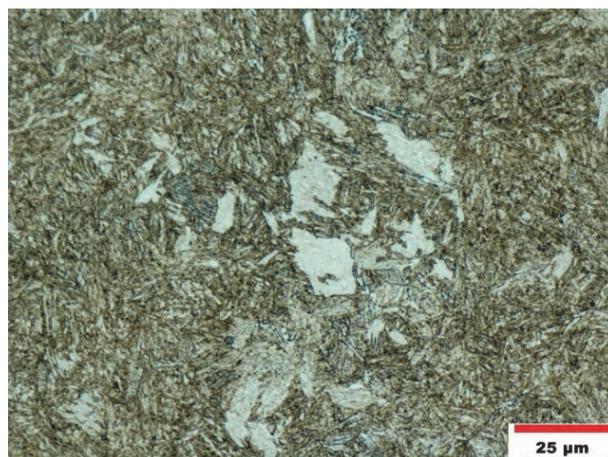
and polishing, firstly in unetched condition, subsequently after etching in Nital 4% reagent. Unetched condition revealed the presence of a large amount of fine MnS inclusions. The material microstructure was found to be tempered martensite. At the edge of the shaft no visually recognizable area of decarburization was observed. Large areas of sorbite/ferrite were present in the whole cross-section shown in detail in Fig. 8. No information about applied heat treatment was provided, therefore, no judgement could be made whether this state of the microstructure is per standard or not.

Fig 8 Detail of the microstructure  
Obr. 8 Snímek mikrostruktury
