## Investigation of Fretting Fatigue Failure of Stud Bolt

Ing. Radek Tomášek; Ing. Adéla Podepřelová; Lukáš Horskák

VŠB – Technical University of Ostrava, Faculty of Materials Science and Technology, Regional Materials Science and Technology Centre, 17. listopadu 2172/15, 708 00 Ostrava-Poruba, Czech Republic

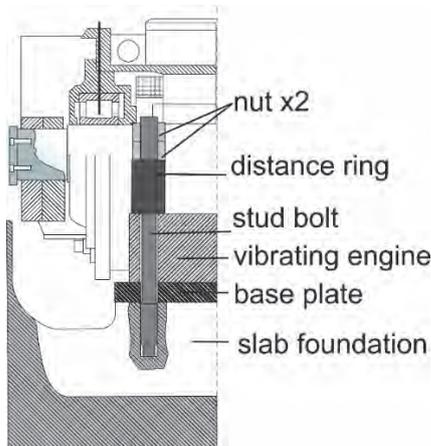
Fig. 2 Assembly diagram  
Obr. 2 Schéma sestavení

Six stud bolts in total were used to fix vibrating motor, and most of them have failed. Fig. 1 shows one side of the motor with fastened stud bolts and Fig. 2 is an assembly diagram. All of the six stud bolts were provided for investigation. Five of these have already failed, and last unbroken one was significantly damaged by plastic deformation as it can be seen in Fig. 3.
